# Rehabilitation of Longitudinal Joints in Double-Tee Girder Bridges

REHABILITATION OF LONGITUDINAL JOINTS IN DOUBLE-TEE  
GIRDER BRIDGES

A thesis in partial fulfillment of the requirements for the

Major in Civil Engineering

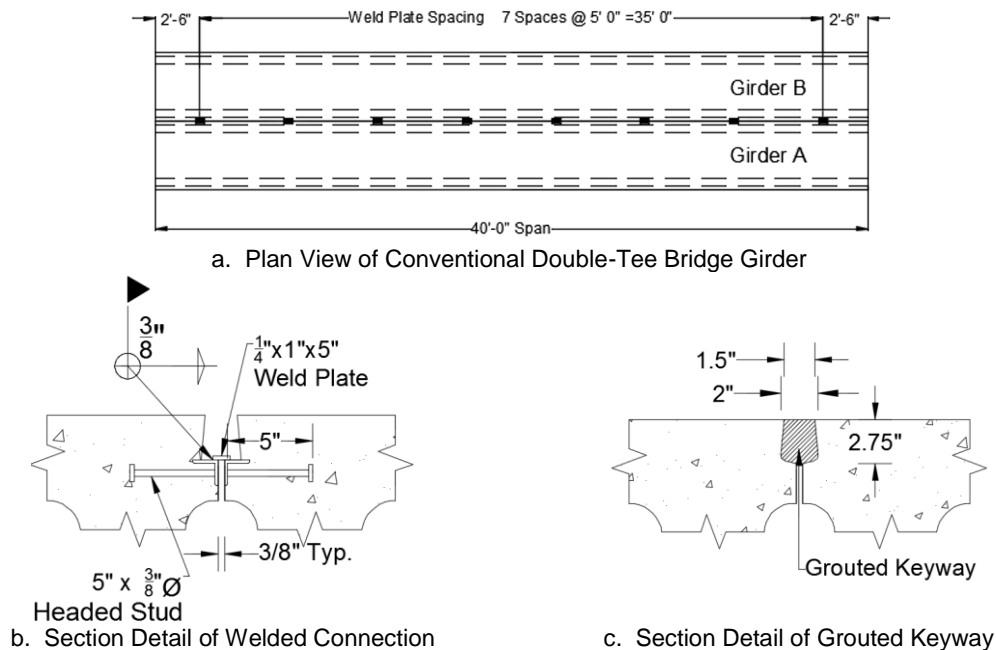
**Figure 1-1. Conventional Double-tee Girder Longitudinal Joint Detail (Konrad, 2014)**

to connect girders. Figure 1-1 shows the current detailing for the double-tee girder bridges.

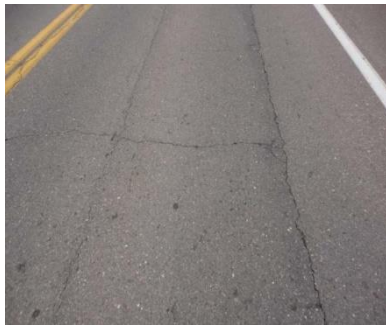
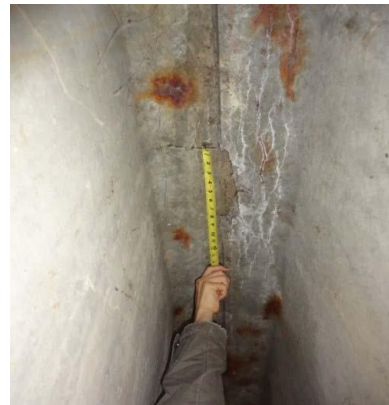
a. Reflective Cracking of Asphalt Overlay

b. Spalling and Corrosion of Underside of Double-tee Girder

**Figure 1-2. Visual Observations of Reflective Cracking, Spalling, and Corrosion of Double-tee Girder Bridges (Konrad, 2014)**

A common problem reoccurring with the existing double tee bridges is the deterioration of the girders longitudinal joints. The inspection of bridges built less than 40 years ago has revealed that there are large cracks along these joints causing reinforcement corrosion and deterioration of the double-tee girders, which can significantly affect the bridges long-term performance. Figure 1-2 illustrates the reflecting cracking of the asphalt overlay, and the spalling and corrosion underneath the longitudinal joint between adjacent double-tee girders. Konrad (2014) studied the behavior of two bridge deck systems under fatigue and static loading conditions (Fig. 1-3) to evaluate the performance of both the current detailing and a new connection. The fatigue test consisted of a loading protocol using a 21-kip load applied at a frequency of

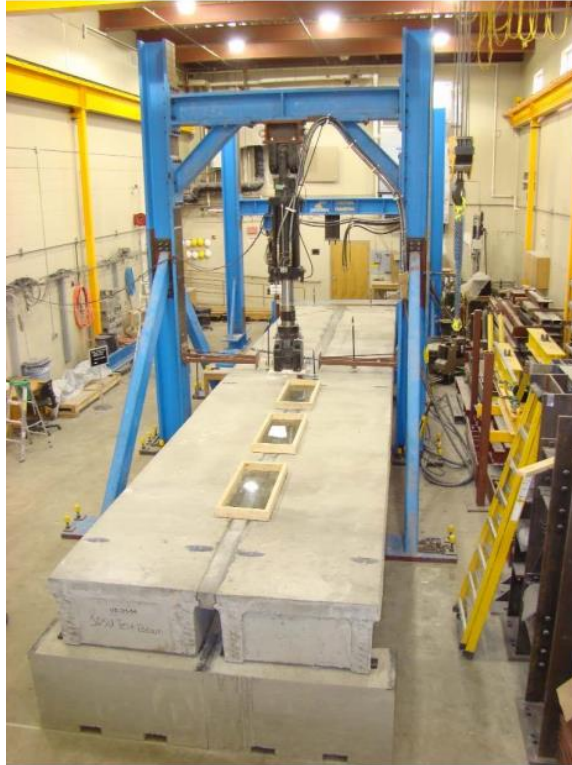
**Figure 1-3. Test Setup for Full-scale Double-tee Girder Testing of Longitudinal Joint (Konrad, 2014)**

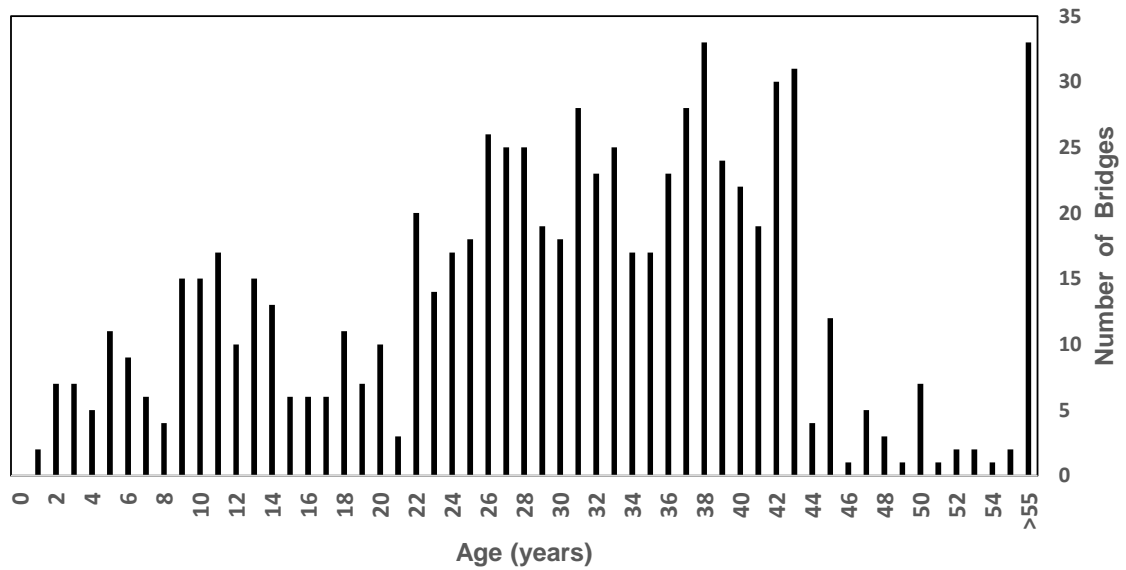
Figure 1-4. South Dakota Double-tee Girder Bridges Age Distribution

A database of SD bridges is available through bridge management software (BRM), which includes bridge location, geometry, age, and condition. This software was used to collect information on double-tee girder bridges. It was found that there are currently 761 double-tee girder bridges in SD. Figure 1-4 shows the age of these bridges. Table 1-1 represents the bridges sorted by year the bridge was built and expected year that the bridge will fail using the experimental data reported by Konrad (2014). The number of cycles to fail the welds in the conventional connection under 21-kip fatigue loading was 62,000. Beckemeyer and McPeak (1995) provided average daily truck traffic (ADTT) values for three road types in SD with different traffic volumes: low (15), medium (50),

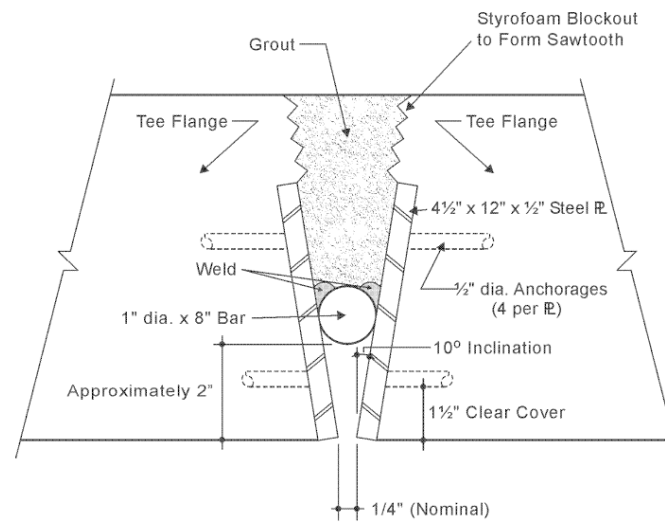
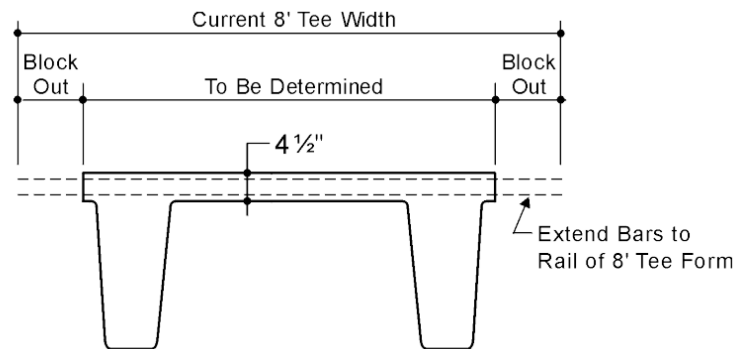
a. "Simple" Detail

b. "Continuous" Detail

**Figure 2-1. Recommended Longitudinal Joint Detailing (Jones, 2001)**

However, the "simple" connection detail was determined to be the most cost-effective alternative. After selection, the "simple" detail was tested for static and fatigue loading. Vehicle loads of 16 kips to a peak of 24 kips were applied to the specimen for a total of 1.5 million cycles. Overall, no signs of failure and degradation were observed.

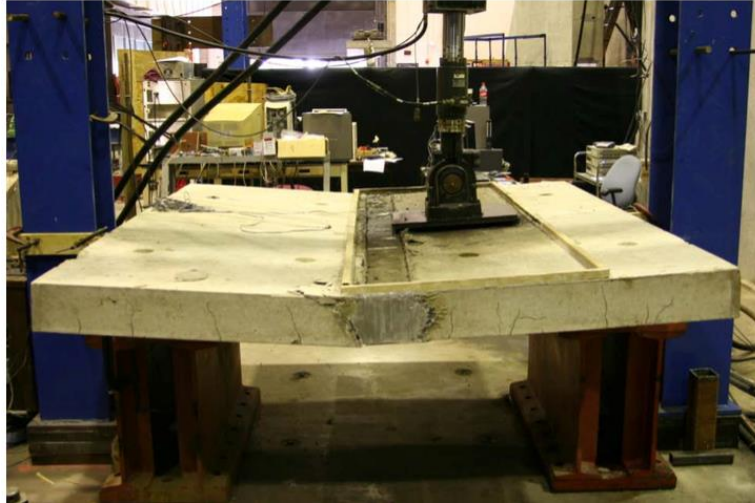
**Figure 2-3. Failure of Longitudinal Joint Specimen with Straight Bars Under Fatigue Loading (Graybeal, 2010)**

The results of the longitudinal joint with the straight bars was similar, however additional cyclic loading was applied to fail the specimen. The loading was 2 and 16 kips for the first 60 thousand cycles, 3 and 21.3 kips for 10 million cycles, 3 and 32 kips for 1.12 million cycles, and finally 340 thousand cycles of 3 and 40 kips. The testing was stopped when the bar fractured crossing the connection interface. No evidence of bonding failure of the UHPC to concrete or UHPC to rebar was observed. Figure 2-3 shows the failure of the rebar at the interface and the flexural cracking of the precast panels.

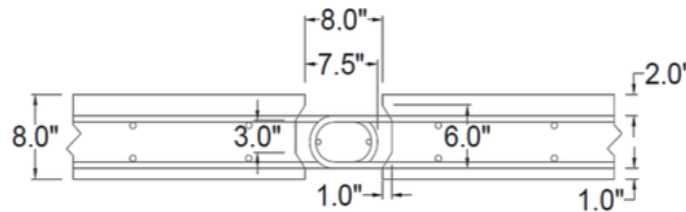
**Figure 2-5. Longitudinal Reinforcement Detail Utilizing Hooped Bars and LMC (Baer, 2013)**

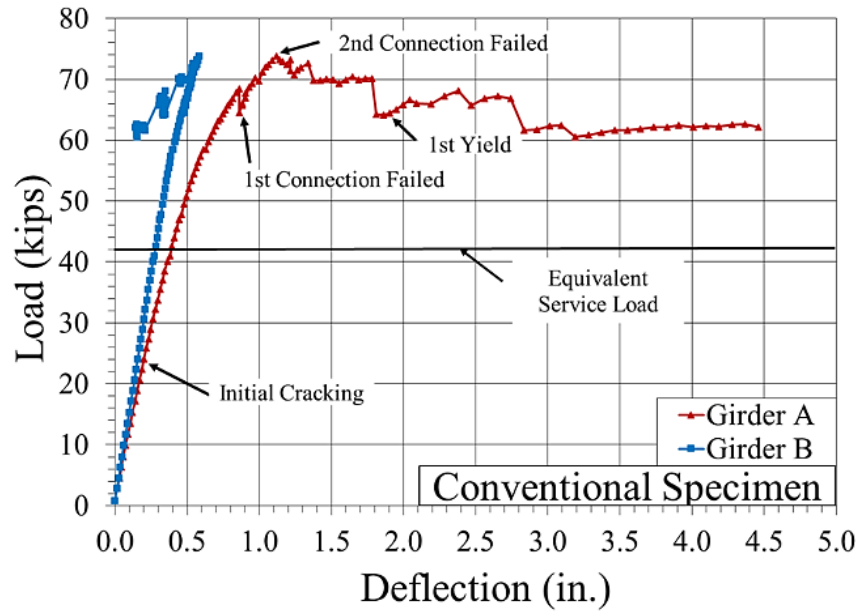
Figure 2-6. Measured Load-Deflection Relationship Under Static Loading for Conventional Specimen (Konrad, 2014)

62,000 load cycles equivalent to 11.3 years in service. Figure 2-6 shows the measured girder load-deformation relationships for the conventional specimen. The failure mode was the headed stud pulling out from the girders at approximately 70 kips. The relative deflection between the girders shows the inability of the welded connections to transfer the shear between girders. In other words, the longitudinal joints acted as pin connections early in the tests. The proposed continuous joint detailing (Fig. 2.7) was tested for more than 800,000 cycles with insignificant stiffness degradation. The load carrying capacity of the proposed specimen was 1.5 times greater than the conventional connections with girder flexural failure (strength test was carried out after fatigue testing). Figure 2-8 shows the proposed detailing force-deformation relationships. The proposed specimen showed a 113-kip strength that was 40 kips higher than that of the conventional specimen. The test showed that the proposed connection can provide adequate load path between girders, and each girder will exhibit relatively the same displacements.

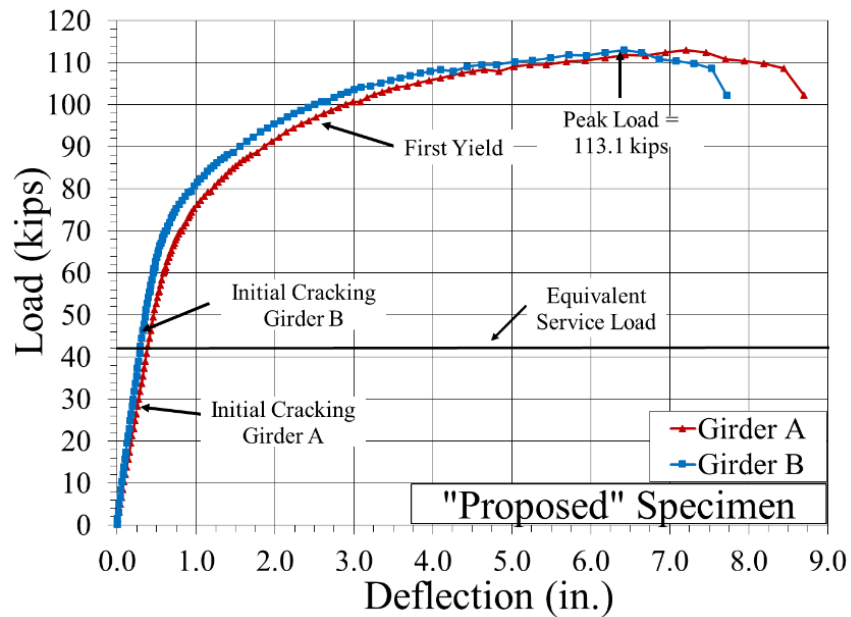
**Figure 2-8. Measured Load-Deflection Relationship Under Static Loading for Proposed Specimen (Konrad, 2014)**

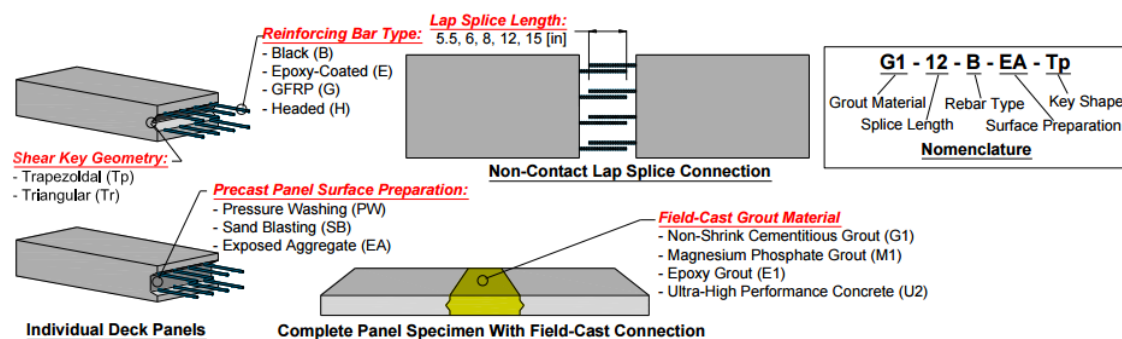
**Figure 2-9. Testing Variables Used for Deck Panel Precast Connections (Haber and Graybeal, 2014)**

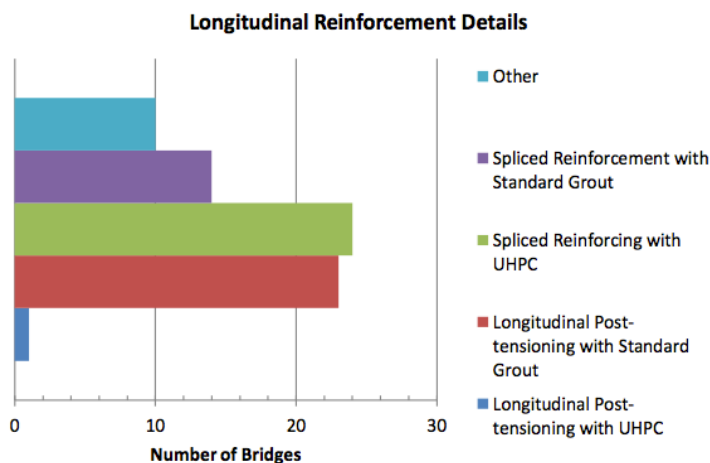
Figure 2-10. Survey Results for Various Longitudinal Joint Detailing (Jones et al., 2015).

Jones and Saiidi (2015) performed a survey of state DOTs regarding practical longitudinal and transverse joints suitable for precast bridge panels. Thirty-two DOTs participated in the survey. The survey concluded the most common type of longitudinal connections among DOTs are UHPC-filled joints with spliced reinforcement and post-tensioned joints filled with standard grout (Fig. 2-10). Deck panel performance was surveyed for common observed problems among DOTs for both full-depth and partial-depth deck systems. The most common issues pointed out by the participants were cracking within the filler material, joint leakage, and reflective cracking.

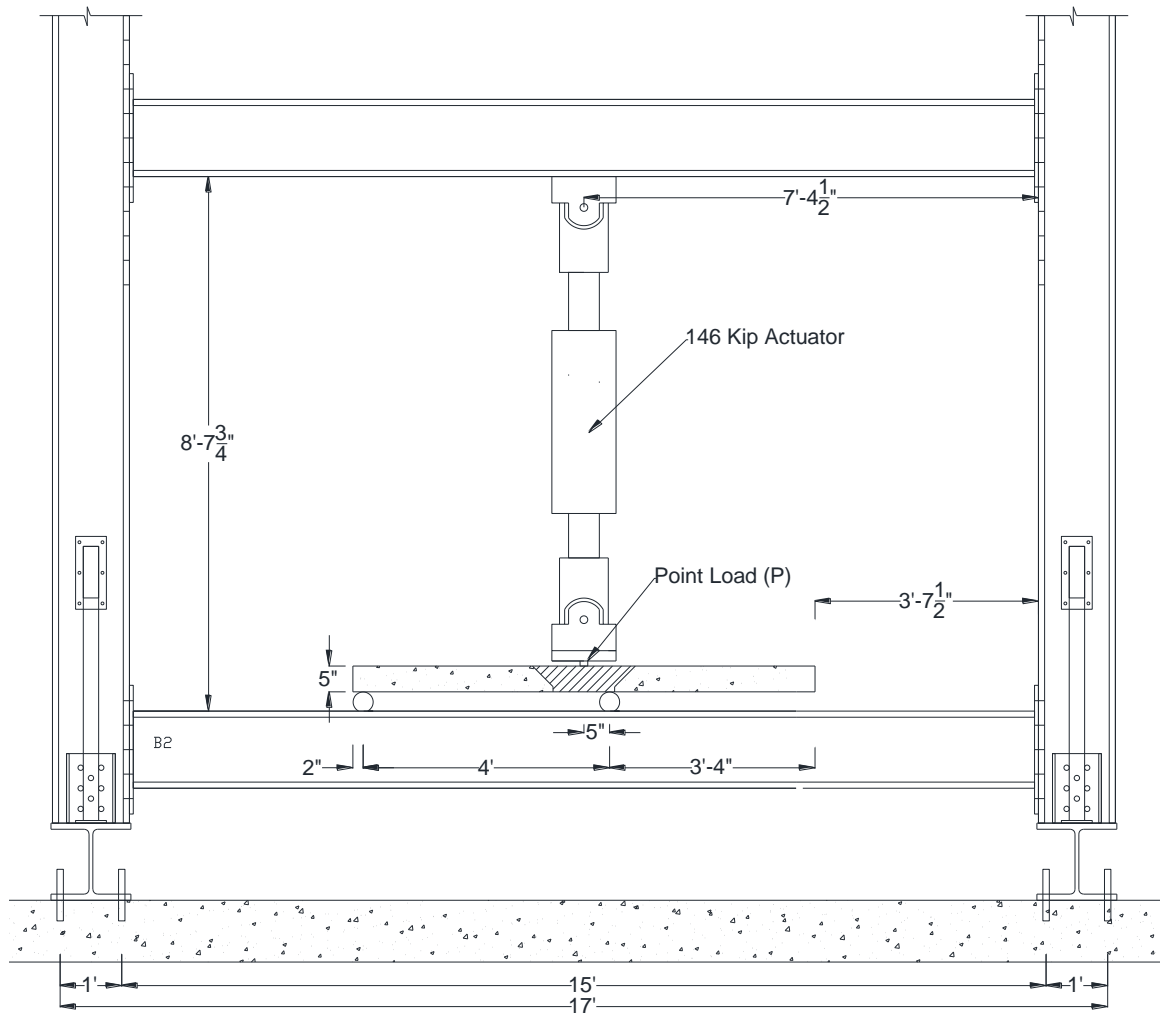
**Figure 5-6. Elevation View of Test Setup**

The beam test setup is shown in Fig. 5-6. A point load was cyclically applied using a 146-kip actuator at 5 in. from the center of the middle support to maximize the shear demand.

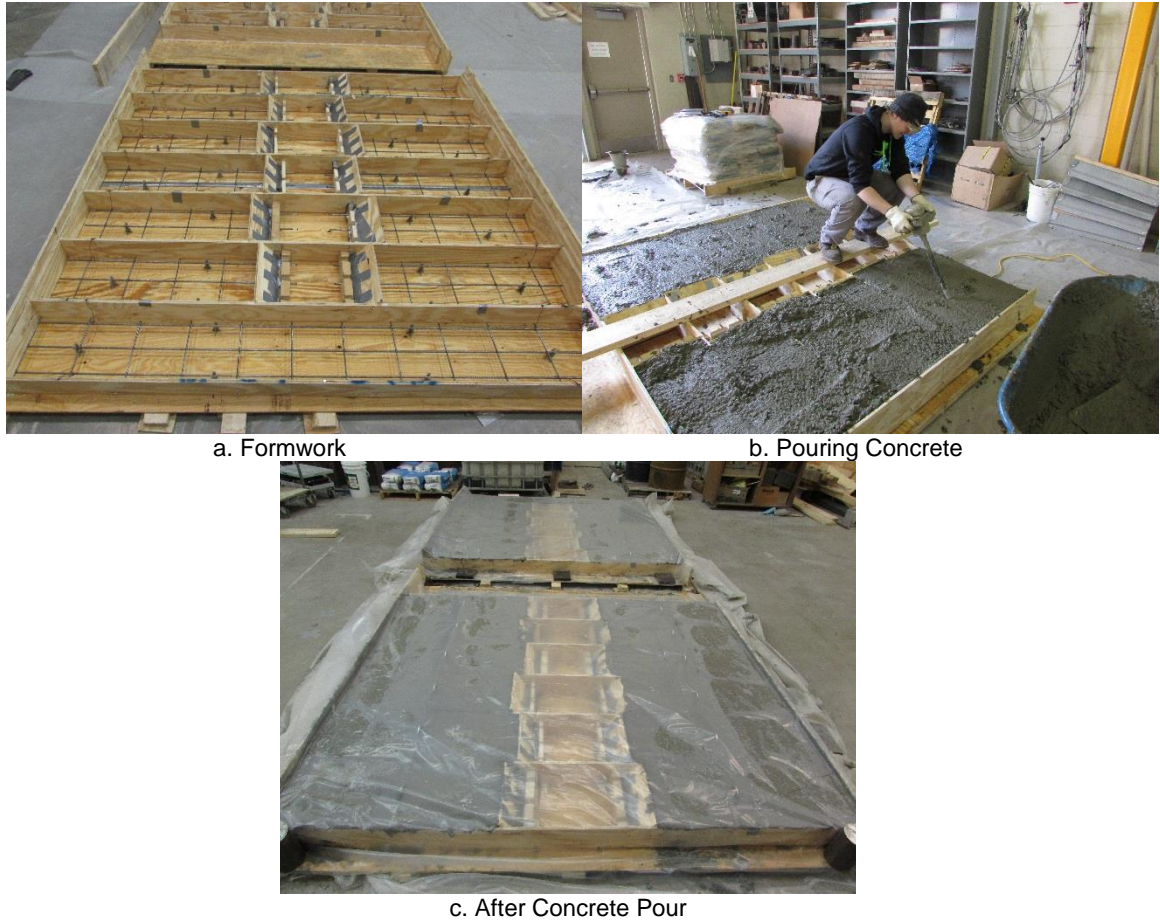
**Figure 5-7. Casting of Concrete Beam Elements**

The beams were fabricated in the Lohr Structures Laboratory at South Dakota State University. Ready mix concrete was utilized for construction. The fresh concrete temperature was 64°F with a slump of 6.0 in. The mix design was based on the current double-tee mix design provided by the manufacturer (Appendix A) targeting 6,000 psi compressive strength at 28-day and a 6-in. slump. A total of 15 standard test cylinders were casted to measure the compressive strengths at various days. The cylinders were sealed and stored next to the test specimens. Vibration during the pour (Fig. 5-7b) was used to insure proper consolidation. Figure 5-7c shows the test specimens after the pour with plastic sheeting placed to facilitate a moist cured condition at ambient room temperature.

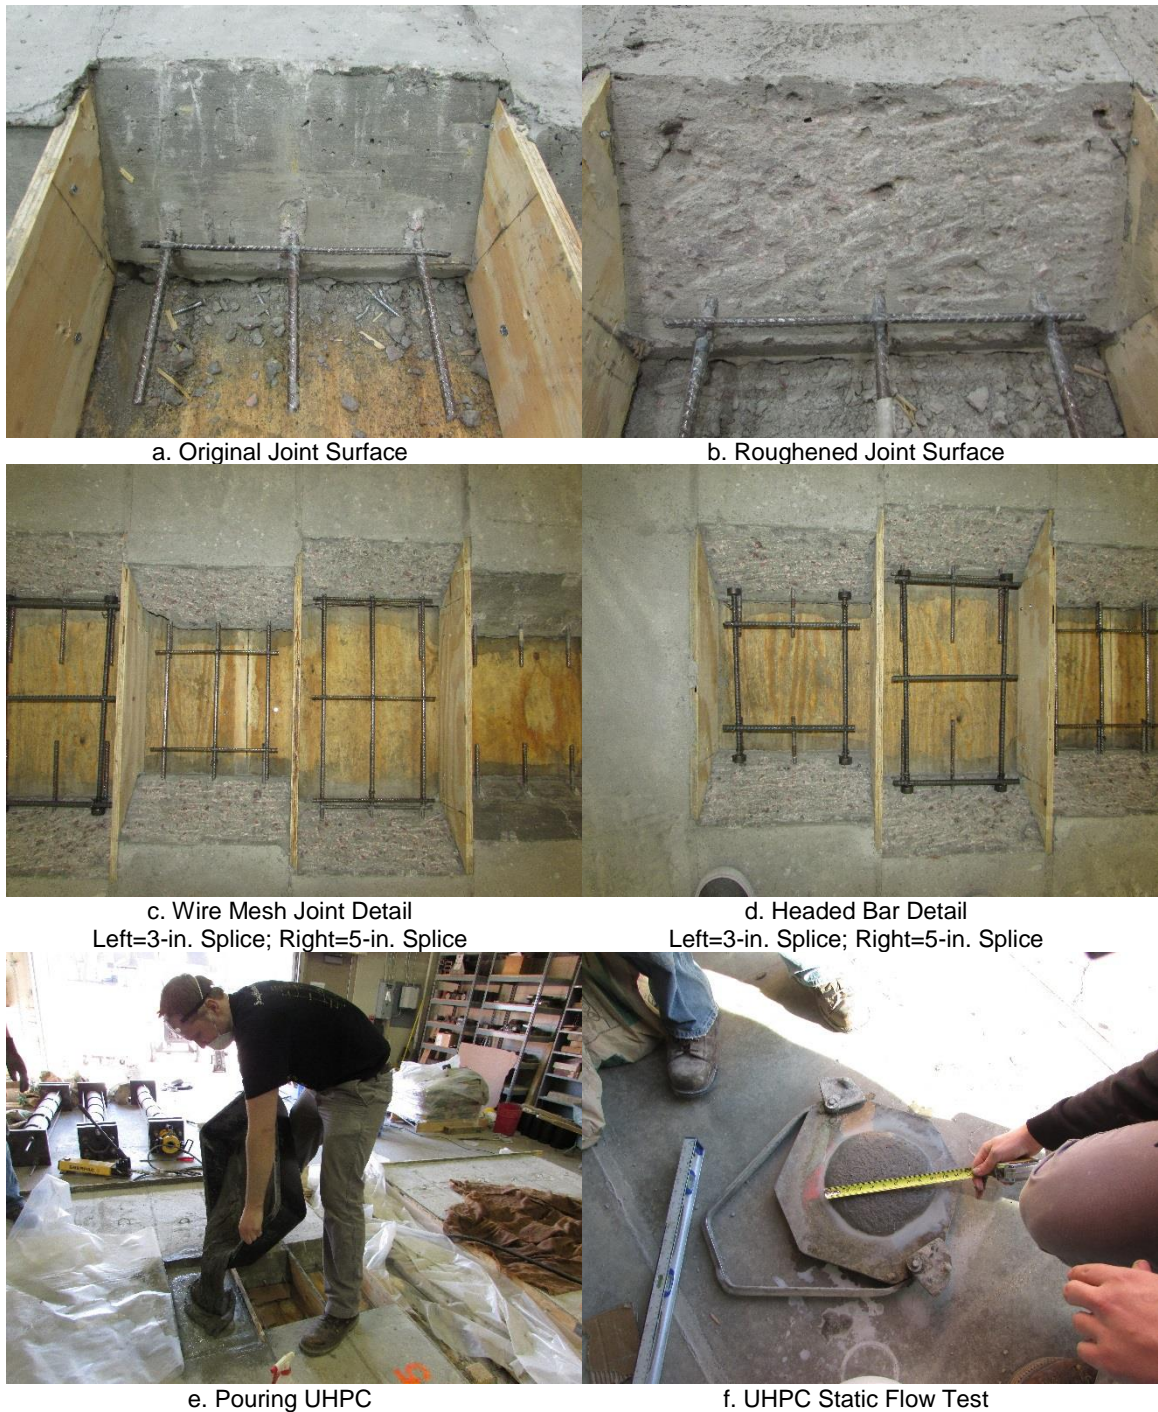
**Figure 5-8. Casting Joint Filler UHPC and LMC**

specimen with 5-in. lap-splice) shows the spliced No. 3 headed bars. The head of the reinforcement was 0.5-in. thick with a diameter of 1 in.

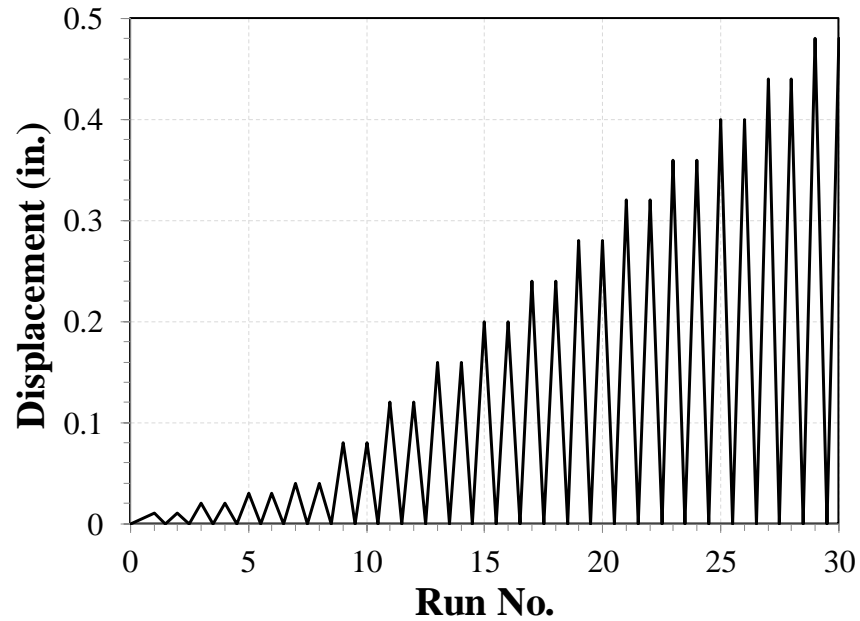
Figure 5-9. Loading Protocol

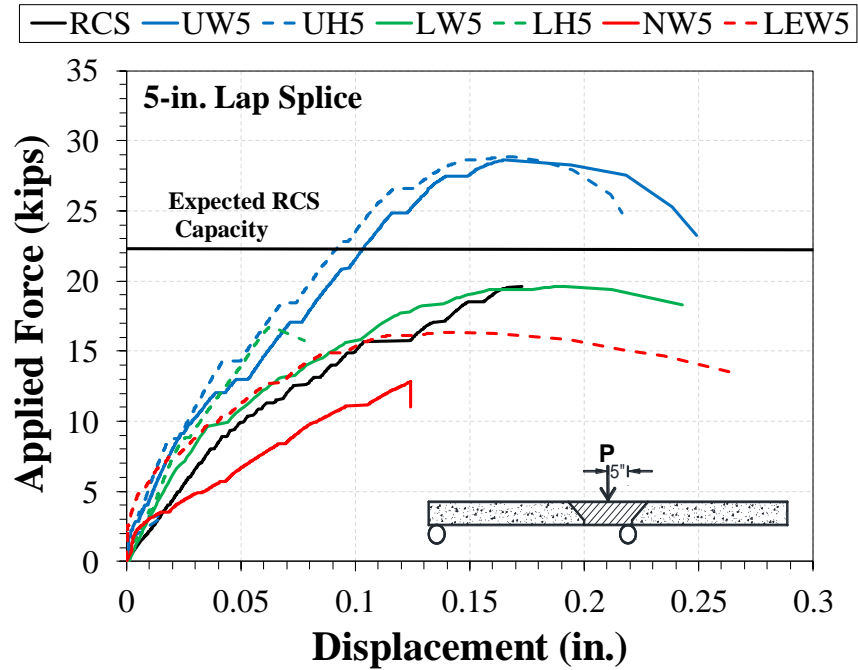
Figure 5-12. Load-Displacement Relationships for beams with 5-in. Lap-Splice

The failure mode of the remaining test specimens was either bar pullout or bar fracture. All test specimens with 5-in. lap-splice (Fig. 5-12) exhibited bar fracture except NW5 (a joint reinforced with wire mesh and filled with conventional non-shrink grout) and LH5 (a joint with headed bars and latex modified concrete). UW3 (a joint with wire mesh and UHPC) and UH3 (a joint with headed bars and UHPC) were the only test specimens with a 3-in. lap-splice (Fig. 5-13) exhibiting bar fracture. Table 5-5 presents a summary of the beam test results including the initial cracking load, the strength load, and the failure mode. The load corresponding to the initial cracking was based on visual inspection of the test beams.

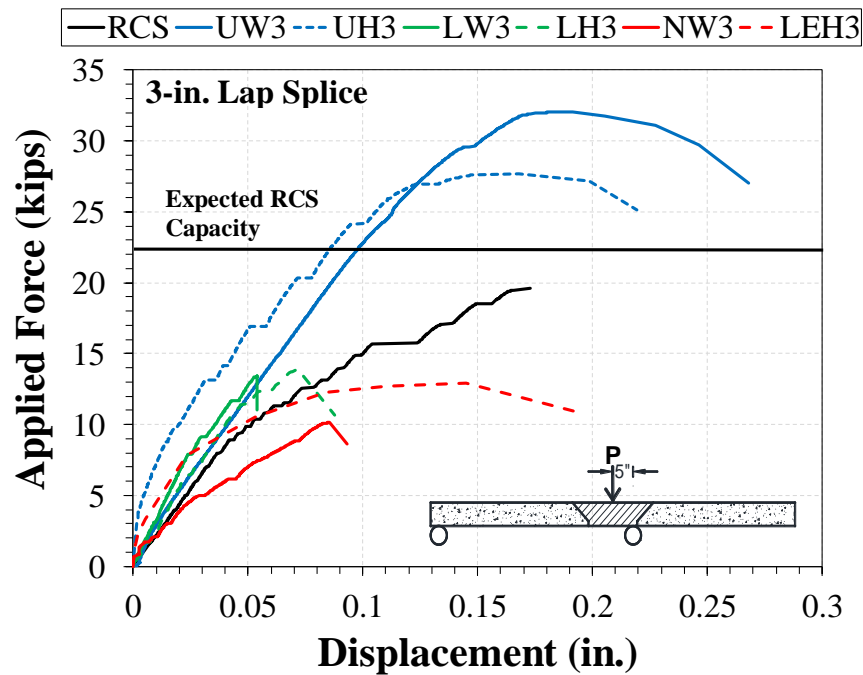
Figure 5-13. Load-Displacement Relationships for Beams with 3-in. Lap-Splice

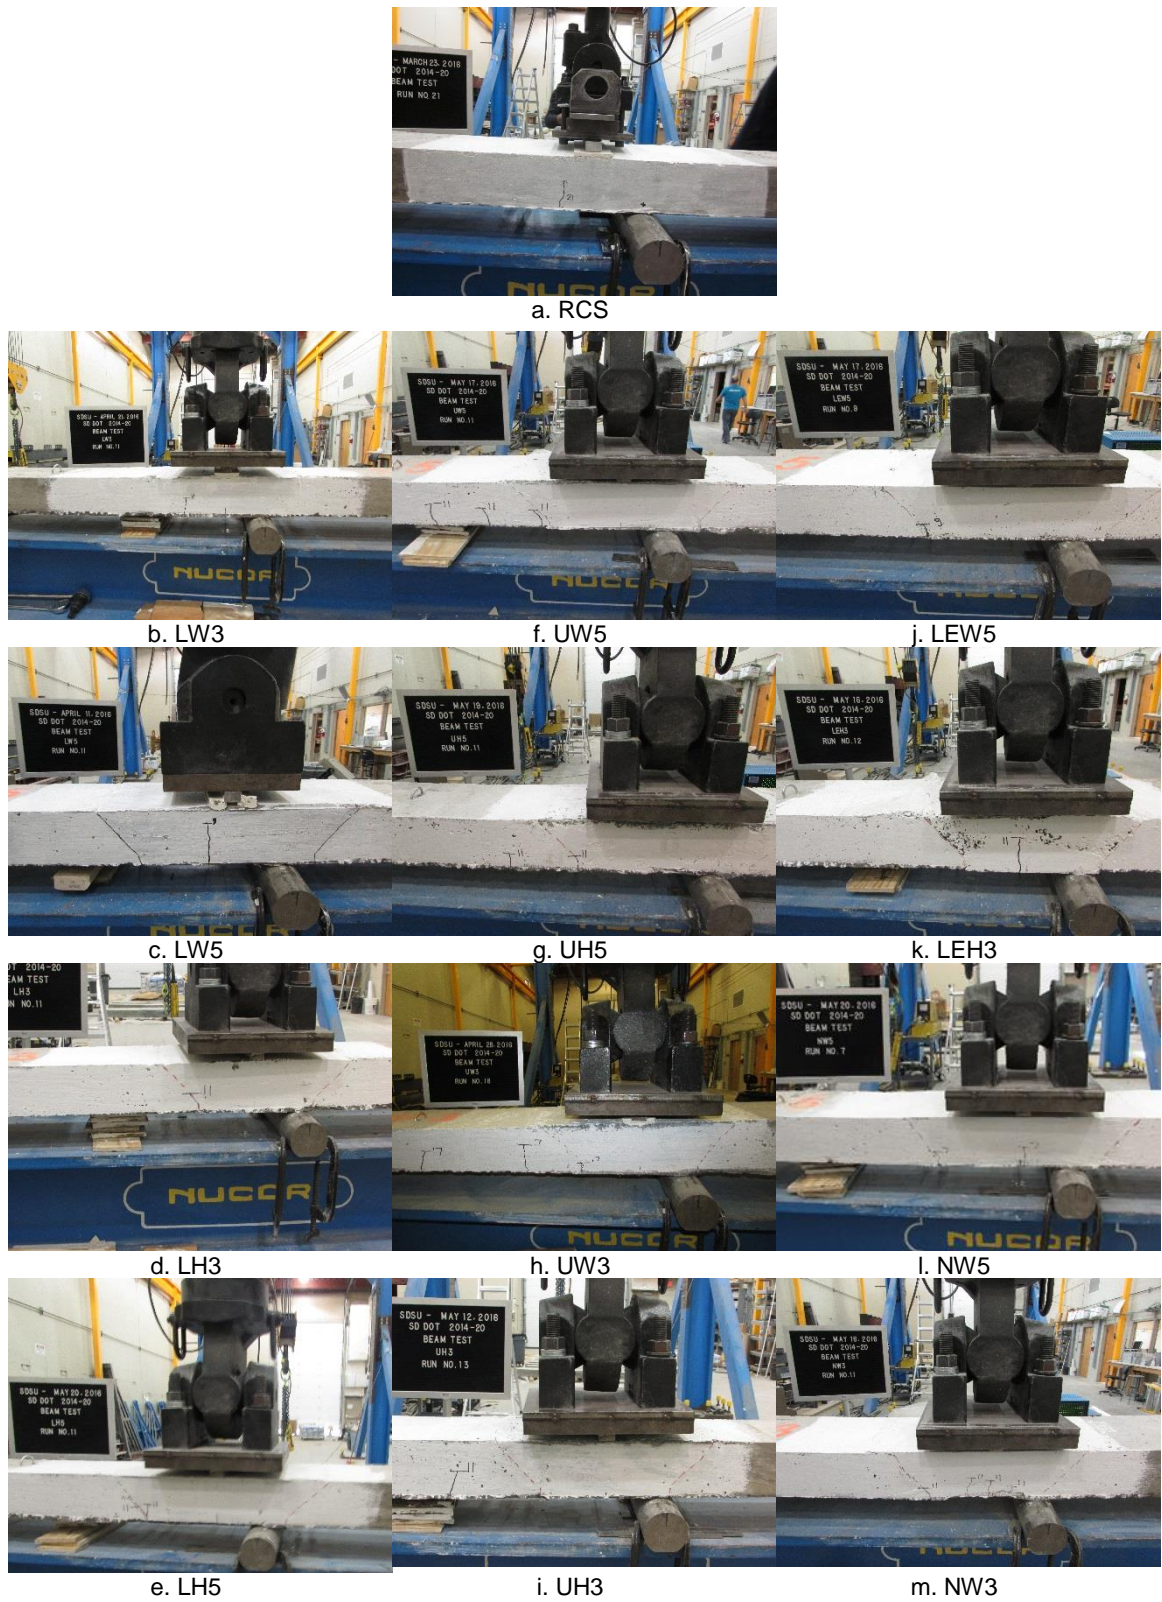
**Figure 5-14. Photographs of Test Specimens at First Cracking**

LH5 had a different failure mode compared to the rest of the specimens in which LMC crushed directly under the applied load. This was attributed to the lower effective depth for LH5 (3.2 in.) compared to that for LW5 (3.7 in.) as well as the 50% higher strain capacity for No. 3 headed bar reinforcement compared to that of D8 reinforcement. The combination of the two parameters resulted in a condition in which the beam concrete (LMC) failed in compression in a brittle manner. On the other hand, LW5 exhibited bar fracture. Also, LEW5 had an effective depth of 3.2 in. that resulted in 16% lower capacity compared to LW5.

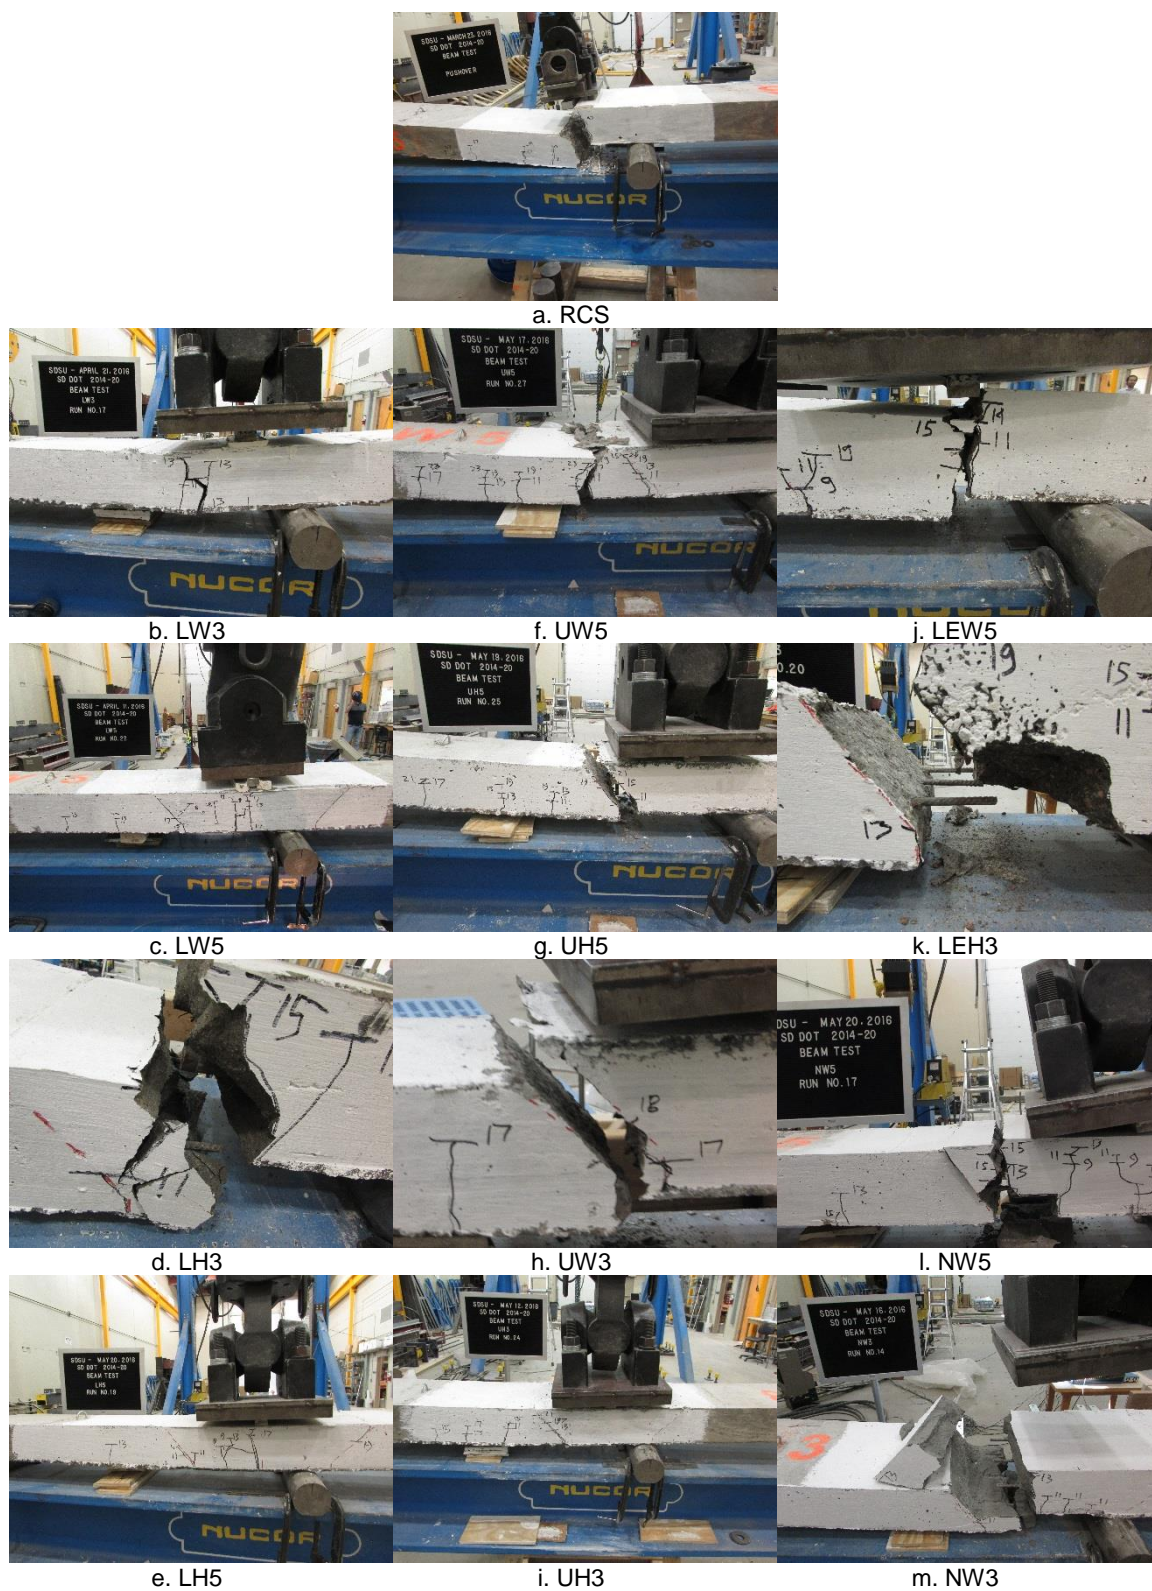
The UHPC test specimens had a 30% higher capacity than the reference specimen. This may be attributed to the 400% higher compressive strength and additional tensile strength provided from the 2% volumetric ratio steel fibers. The first crack (Fig. 5-14) then failure (Fig. 5-15) of all specimens except those incorporating UHPC occurred inside the joint directly under the applied load where the bending moment was maximum. In the UHPC specimens, all the flexural cracking was shifted outside of the joint.

The bond between the UHPC and concrete was high resulting in monolithic behavior. Slippage between the two materials measured with LVDTs was insignificant. In UW5, the steel wire fractured outside the UHPC joint in the precast concrete. The steel wires fractured at the UHPC-concrete interface in other UHPC specimens (UW3). However, concrete aggregate was attached to the UHPC at the interface indicating sufficient bond.

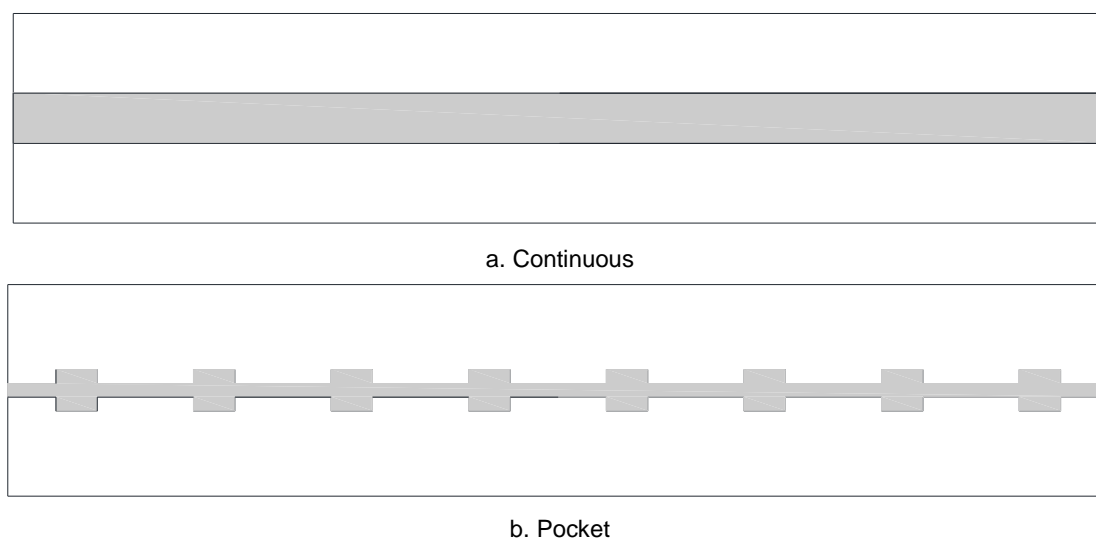
**Figure 5-16. Rehabilitation Concepts - Bridge Plan View**

**Option II** – “pocket” concept (Fig. 5-16b) consisted of discrete pockets exposed by demolishing the girder flange concrete and reinforced with steel bars. In between the pockets the damaged material in the longitudinal joint is removed and replaced with a filler material such as UHPC.

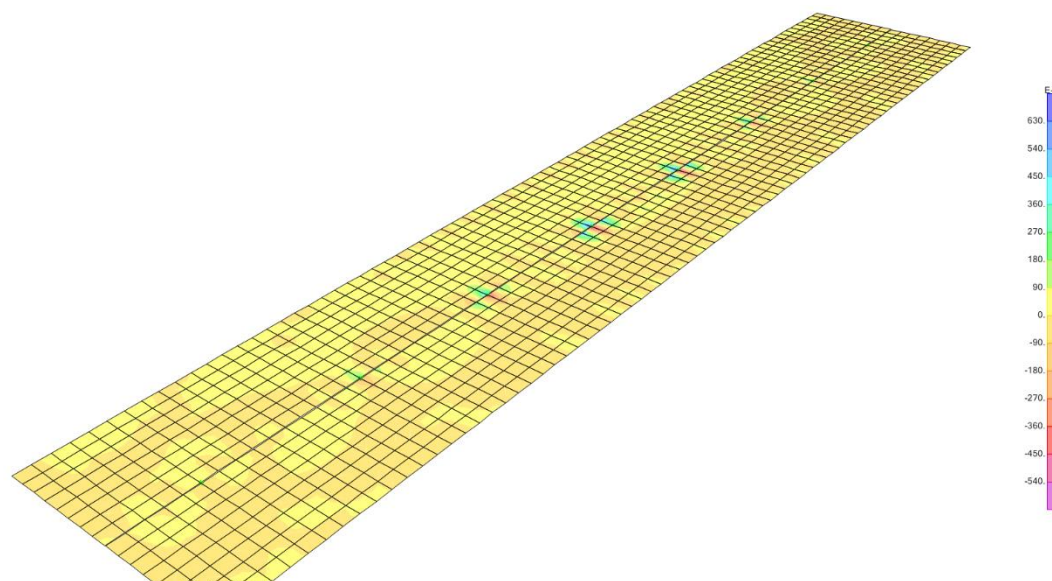
**Figure 5-22 “Pocket” Model  $S_{23}$  Stress contour at Service I Limit State**

maximum shear stress is 210 psi for an 18-in. wide pocket (or 630 psi for a 6-in. wide pocket). Since this shear stress is less than the bond strength between UHPC and concrete, no cracking is expected under the service limit state loads. Furthermore, the maximum shear stress at the Strength I limit state is 533 psi for an 18-in. wide pocket (or 1,400 psi for a 6-in. wide pocket).

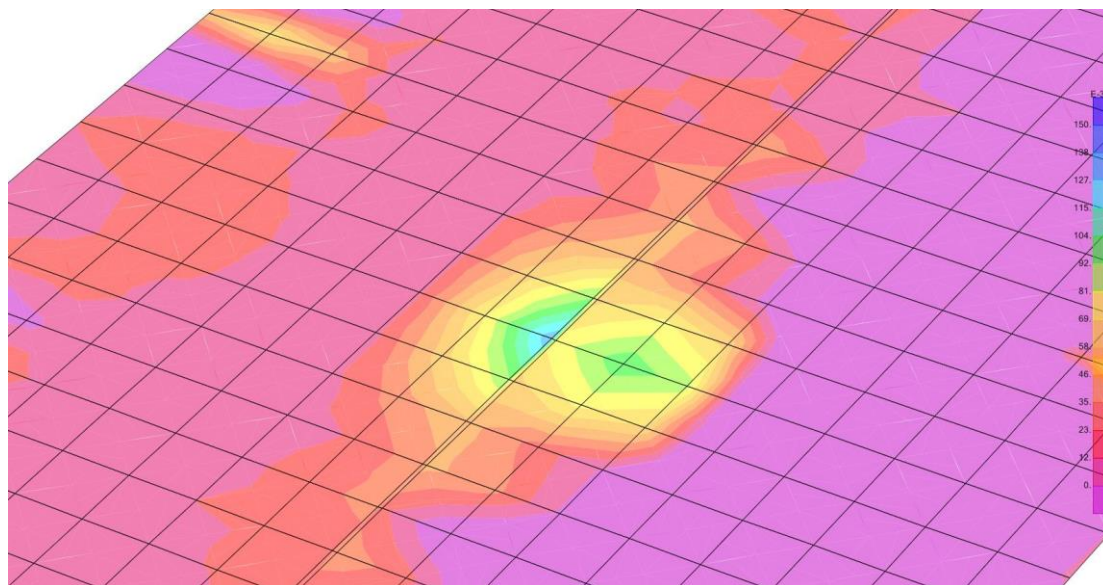
**Figure 5-23. “Continuous” Model S<sub>23</sub> Stress Contour at Service I Limit State**

The maximum calculated shear stress in the connection of the “continuous” analytical model was 160 psi at the Service I limit state (Fig. 5-23) and 360 psi at the Strength I limit state. The continuous joint shear capacity is 408 psi (13% greater than the demand) based on the AASHTO shear friction equation for a 5-in. thick LMC continuously reinforced with D8 steel wire mesh ( $A_s = 0.24 \text{ in}^2 \text{ per ft}$ ).

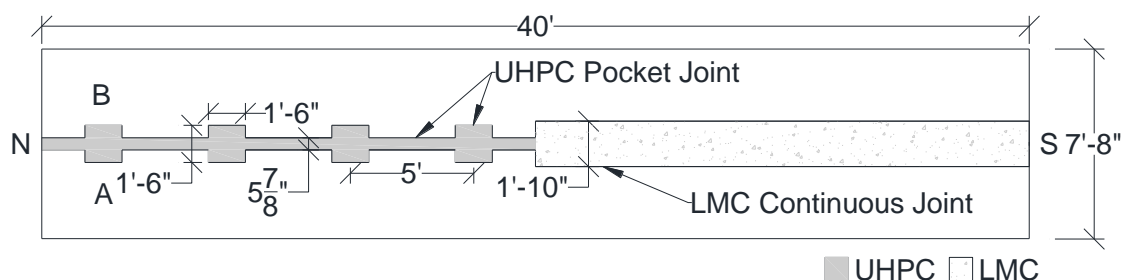
Figure 6-5. Plan View of Rehabilitated Test Specimen

The LMC continuous joint was 5-in. deep and 22-in. wide reinforced with 4 in. by 4-in., D8/D8 welded wire mesh. The new wire mesh was spliced to the deck existing wire mesh with at least 5-in. splice length in the transverse direction of the bridge. Furthermore, two 10-ft long meshes were lap-spliced with No. 4 bars in the longitudinal direction of the bridge to complete the joint and to provide continuity.

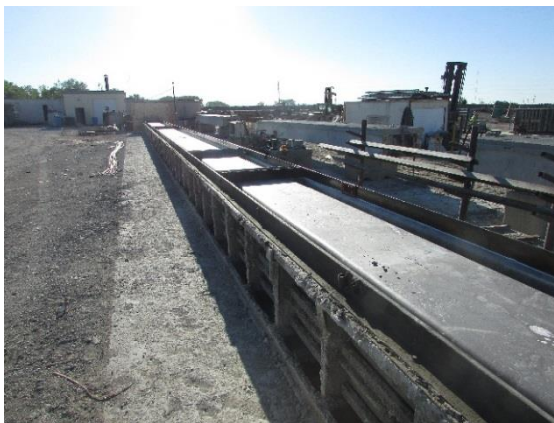
a. Prestressing Bed

The girders were fabricated in Mitchell, South Dakota. The girders were prepared and cast in four days on a 140-ft long prestressing bed (Fig. 6-9a). On day one, the prestressing strands were initially tensioned to 3,000 lbs to remove slack in the tendons,

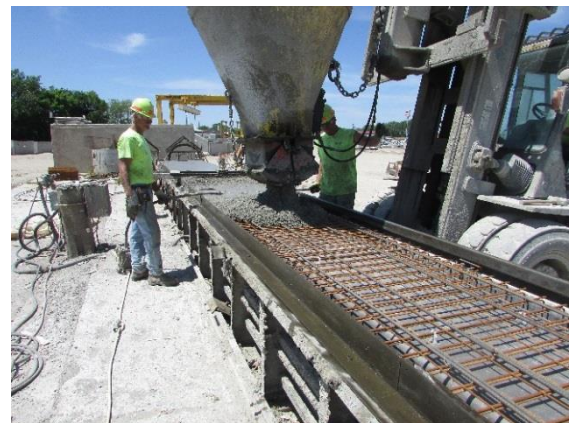
b. Concrete Casting

and strain gauges were installed on the tendons. On day two, the strands were jacked to 31 kips then wire mesh and longitudinal joint anchors were placed in the prestressing bed. On day three, the embedded concrete strain gauges were installed in the deck between wires in the mesh. Subsequently, the girders were casted (Fig. 6-9b). Fresh concrete properties (e.g. slump, air, density, and temperature) were measured and 18 standard cylinders were collected. The girders were covered and steam cured overnight. On day four, the concrete strength was 5,680 psi, which was higher than the minimum release strength of 5,000 psi. Subsequently, the strands were cut with a torch (Fig. 6-9c) and the girders removed from the prestressing bed (Fig. 6-9d). Strain data was measured during various stages of the construction to measure elastic shortening losses.

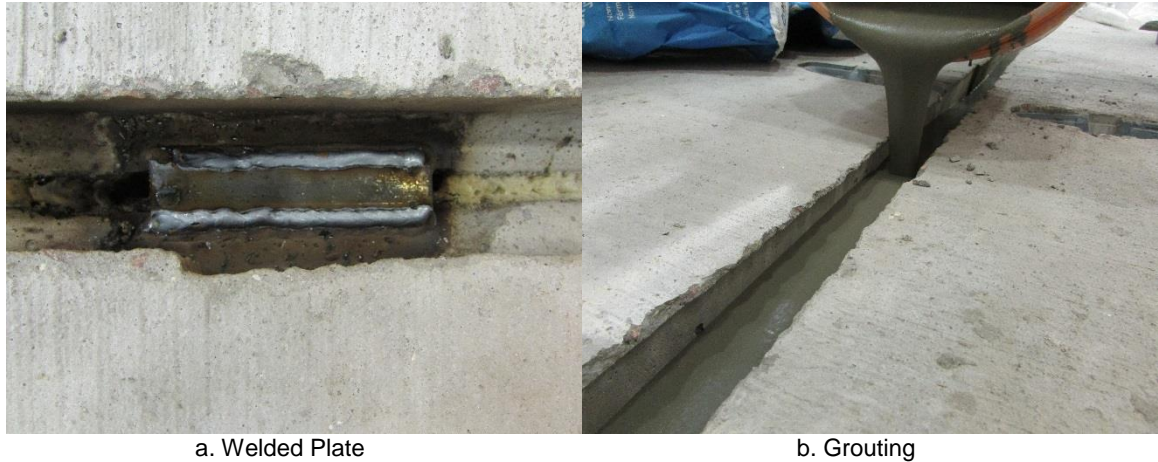
**Figure 6-11. Fabrication and Grouting of Conventional Joint Detailing**

The girder steel angles and steel plates were welded in the lab (Fig. 6-11a) by a certified welder to connect the adjacent girders. Subsequently, the keyway was filled with non-shrink grout (Fig. 6-11b) to complete the joint. The grout was cured three days in which the compressive strength reached 5,853 psi.

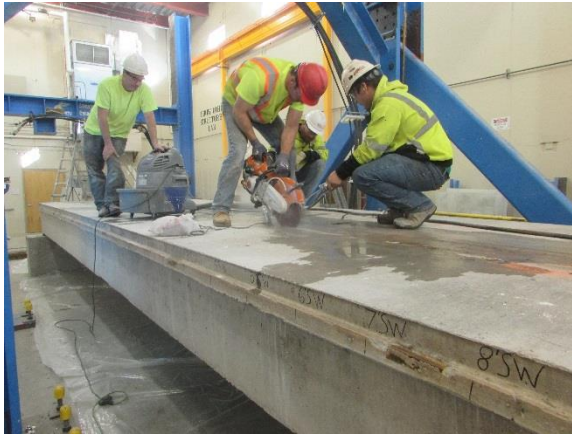
a. Saw-cutting

The continuous joint was demolished and cast in two segments to avoid instability of the bridge. Each segment was 25% of the bridge length. An actual double-tee girder with continuous exposed bars at the both sides of the girder may become unstable in the field. The rehabilitation began with saw-cutting (Fig. 6-12a) the perimeters of the joint with a depth of 1 in. Then, 15- and 30-lb pneumatic hammer chippers (Fig. 6-12b) were utilized to remove the deck concrete with a 45-degree side slope for both the continuous (Fig. 6-12c and 6-12d) and pocket joints (Fig. 6-12e).

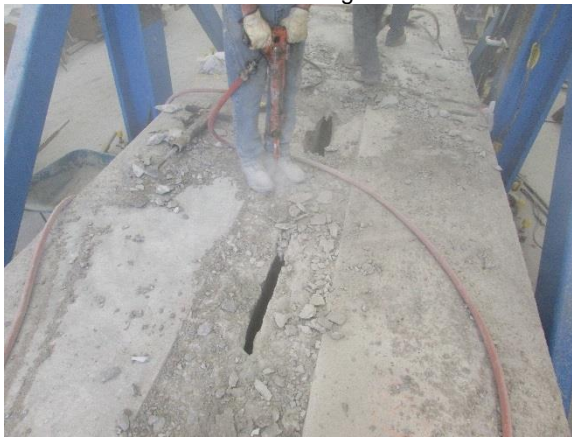
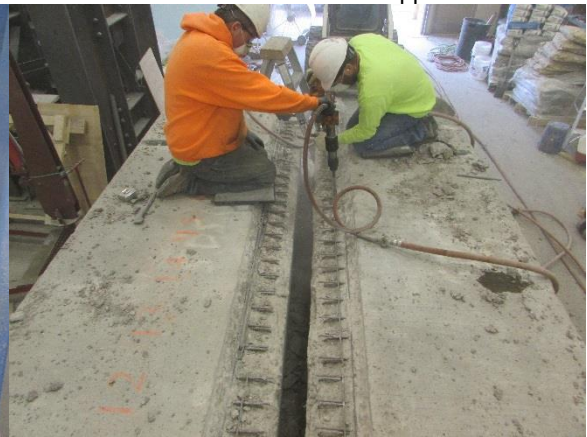
c. Continuous Joint Demolishing – Segment I

d. Continuous Joint Demolishing – Segment II
